ADDENDUM NO. 2

To all Bidders on the Project titled: Life and Physical Science Building Abatement and Demolition Project

CR_Project-0852: Demo OLD Library, Life Science and Physical Sciences Building implementation Utilities Demarcation

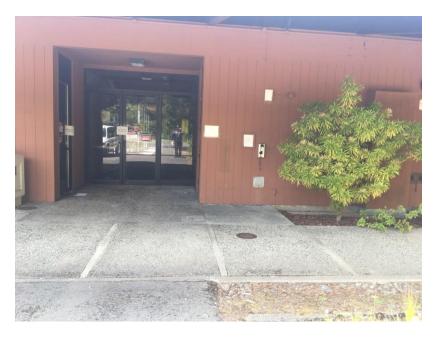
A. Picture number one is for Old Library water shut off

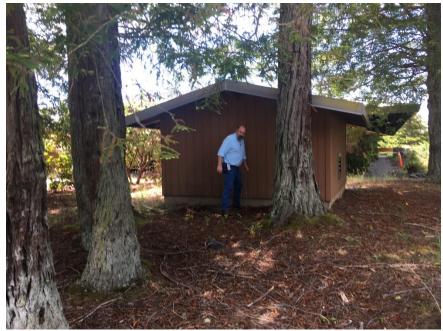
B. Picture number two is where both the sewer and the Storm drains are. They are both located in this approximate area. These will need to be sealed in concrete at both ends near the building and at the input to the main line

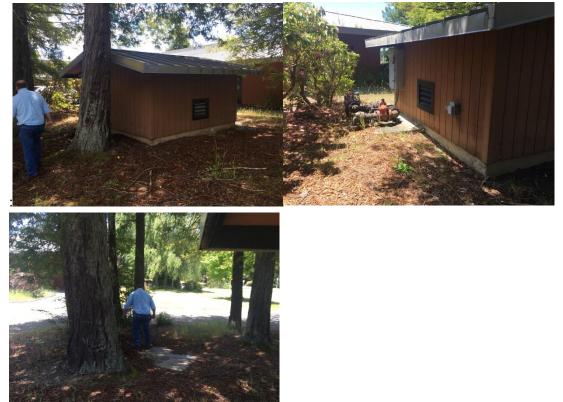
C. This Picture shows the transformer shed and water boost irrigation pump set up. The transformer shed and transformer go away as part of this demo. The booster irrigation pump will be pulled by the college prior to demolition start. There is a 12KV vault shown in photo

007 below. All 12KV infrastructure will either be abandoned in place or abated as much as practical. 3ph power into the Library will abated back to the transformer as much as practical.

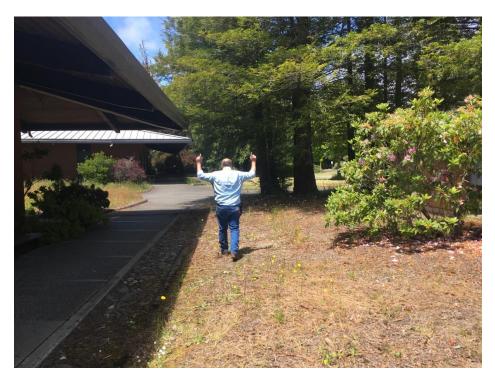
E. Picture number six is the hydronic lines tween the old Library and the Life Science building. Abate as much as practical. Abandon the remaining in place.

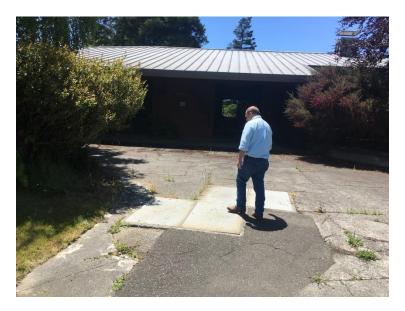
A. 12KV and other signals for Life Science would be abandoned back to these pull boxes as appropriate.

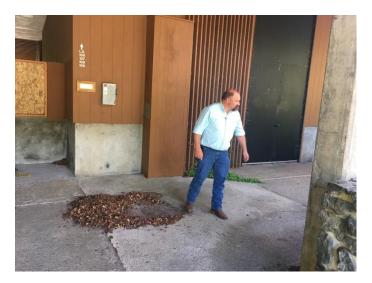
B. Picture number nine is likely a gas shut off valve for life science as well as sewer clean out. College will verify gas shut off from this valve

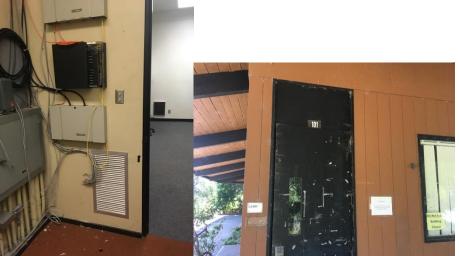
C. Pictures 10, 11 and 12 and 13 are in the life science building showing fiber. The college will have these inactive prior to the start of Demolition

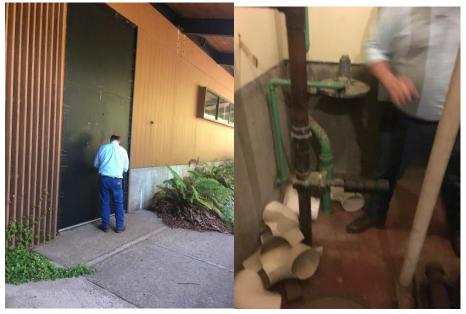
E. The pictures below show the boiler room . This shows the Water and gas line inside the building that should be isolated at the valves. **College will determine if there is a better external source of building isolation**,

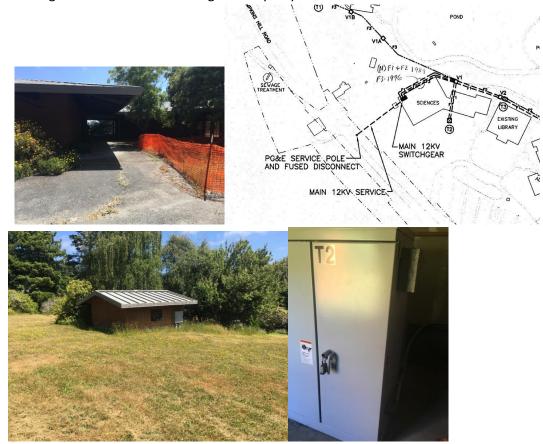
H. This picture shows the breezeway where 12KV runs from the trunk in front to the Transformer in the rear of the building. None of this 12KV nor the Transformer and shed to the rear of the building is to be demoed or damaged in any way.

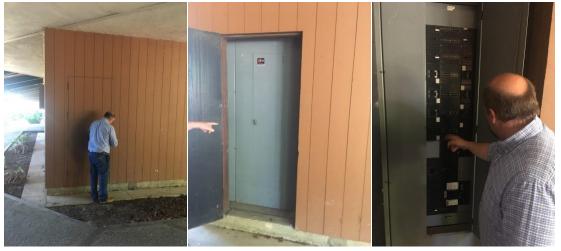
K. These photos shows where 208 3-Ph comes into Physical Science and then feeds over to Life Science. This power is to be disconnected at Transformer T2 and as much of the wire abated as practical. This conduit is to remain intact if at all possible. The college may re-use it for pathway lighting in the future.

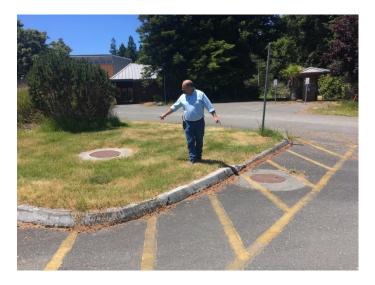
G. Picture number 17 shows the sanitary sewer and storm drain for physical science. Note it is some distance out from the building. The lines to both of these are to be sealed in concrete at both ends as part of the abatement and building demolition project.

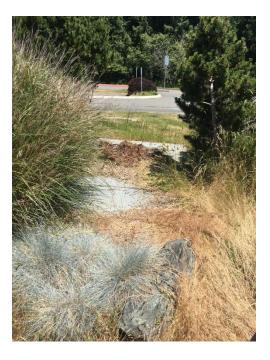
H. Picture number 18 shows the 12 KV lines heading over to the vault near the old library. Note that fire hydrant is just to the right hand side of this photo. Do not disturb Hydrant.

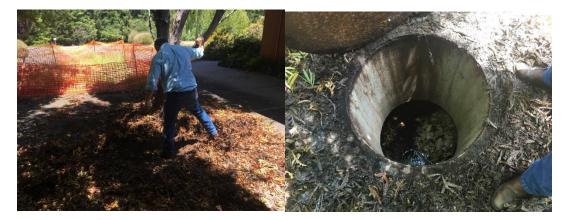
K. Picture 21 and 22 show the access to the neutralizer pit that contains oyster shell etc. This will be cleaned out by the college prior to Demolition and it is to be demolished and sealed so that the main sewer line remains intact.

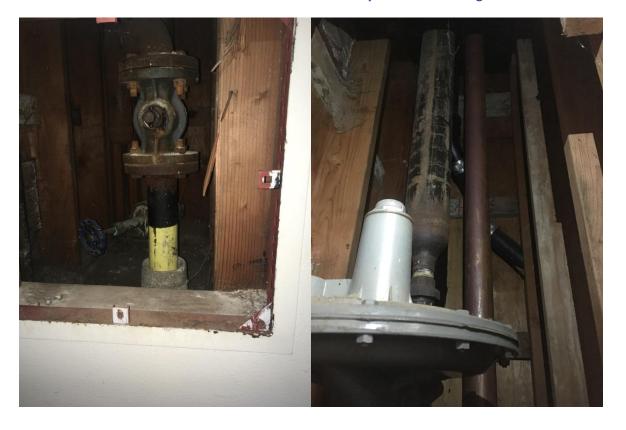
M. Picture 26 and 27 shows Water and Gas valve is located just on the other side of the wall inside the classroom PS 104. This may have to be the demarcation point for this gas. The college will later seal access to this valve from a location away from the building.

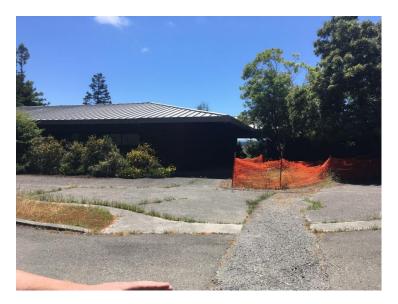
O. Picture 24 shows the hard scape outside the broken gas line most of this hard scape will go away back to the sidewalk.

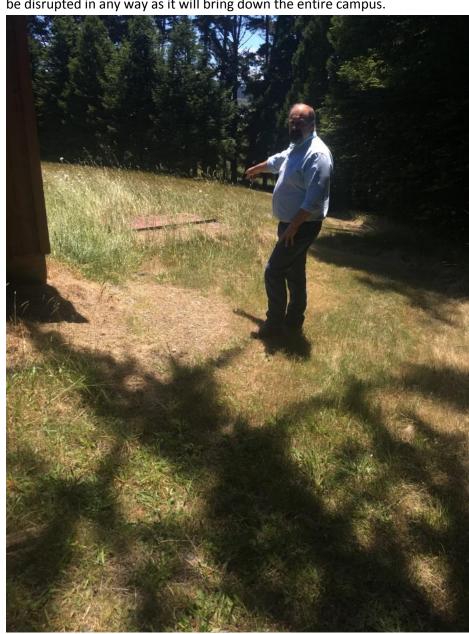
R. Picture 28 is the wharf hydrant behind. Do not disrupt this line or hydrant.

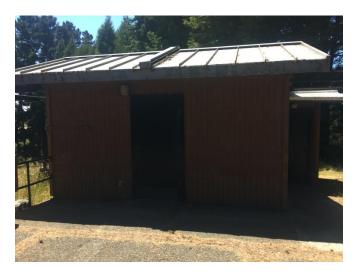
Picture 30 is the observatory. Abate with Caution as it sits on top of the MAIN campus 12KV feeder conduits.
